## DIGITAL PHOTOGRAPHS

**Date:** March 17, 2010  
**Time:** 9:29 a.m.  
**Direction:** W  
**Photo by:** Charlie King  
**Exposure #:** 001  
**Comments:** The east side of the Nutronics building facing Peoria Road.

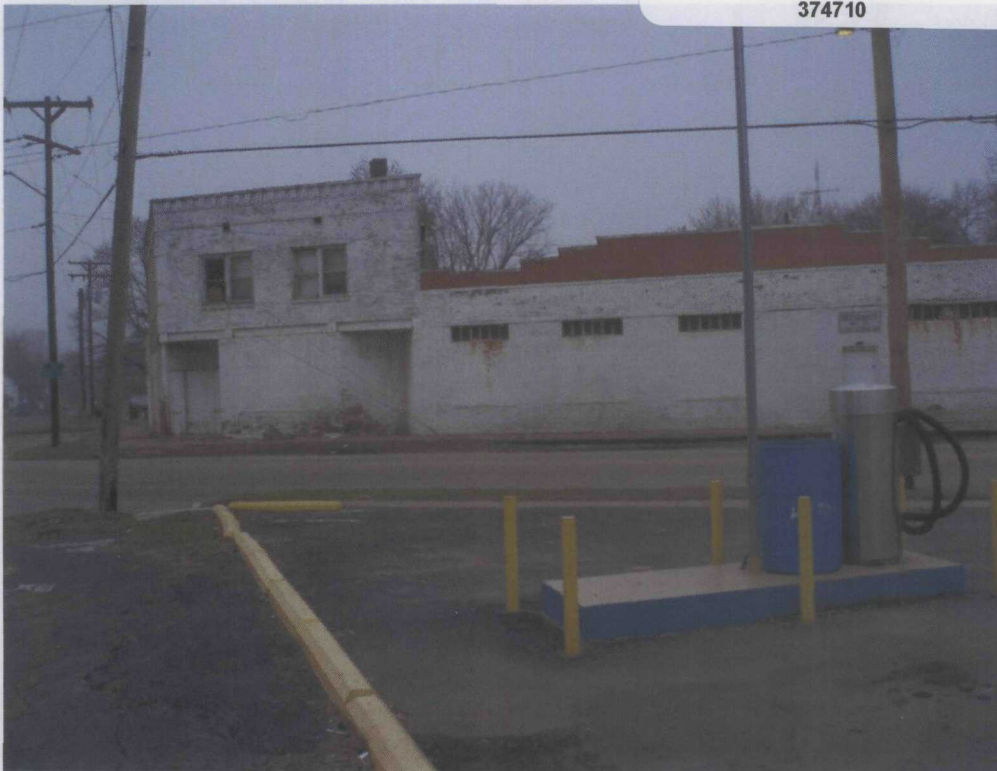
The sign above the door on the side of the building is shown close-up in photo # 002.

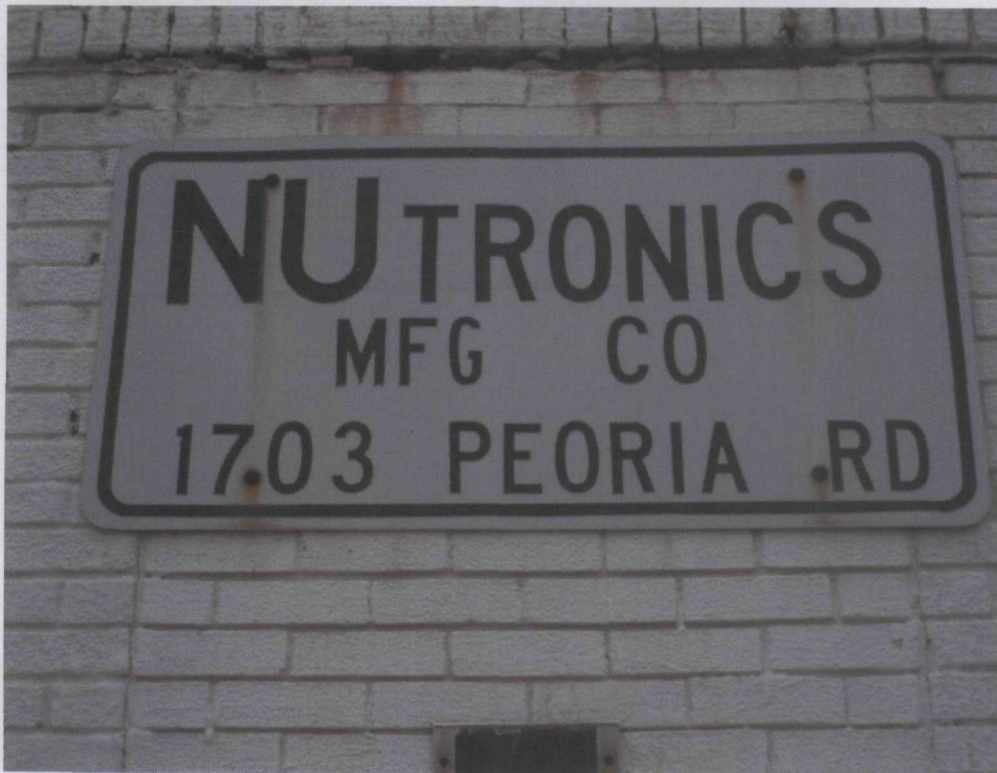
**Date:** March 17, 2010  
**Time:** 9:30 a.m.  
**Direction:** W  
**Photo by:** Charlie King  
**Exposure #:** 002  
**Comments:** A sign for the Nutronics business on the east side of the building.

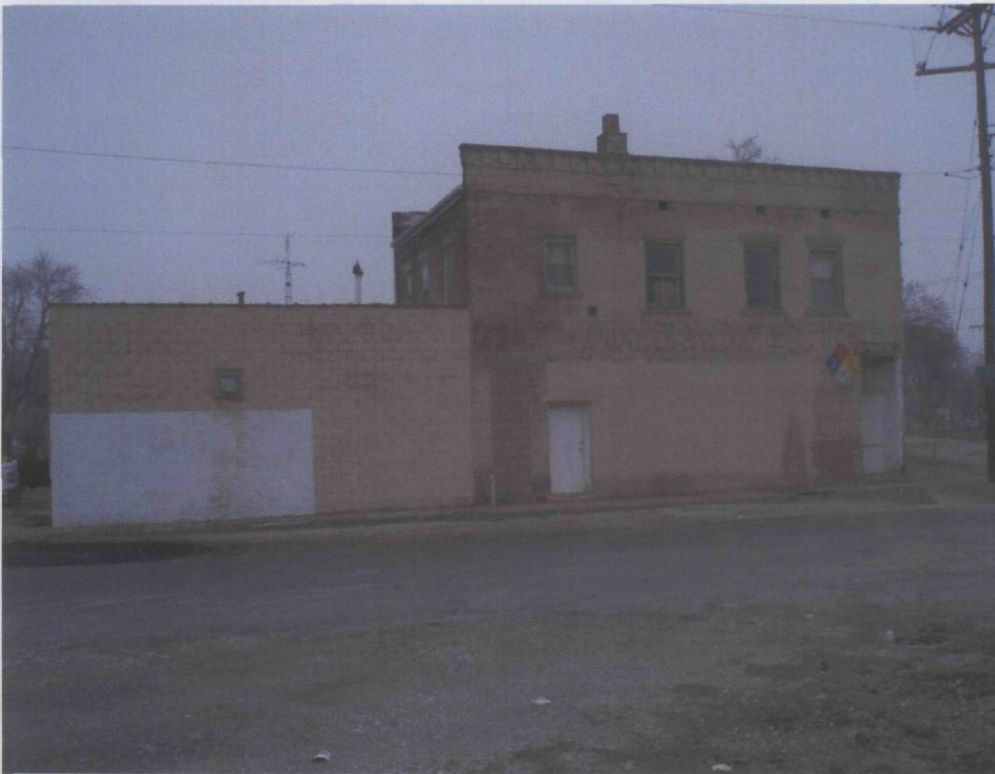
**Date:** March 17, 2010  
**Time:** 9:33 a.m.  
**Direction:** N  
**Photo by:** Charlie King  
**Exposure #:** 003  
**Comments:** The south side of the Nutronics building facing Ridgely Ave.

The hazardous materials warning placard on the building is shown enlarged in photo # 004.

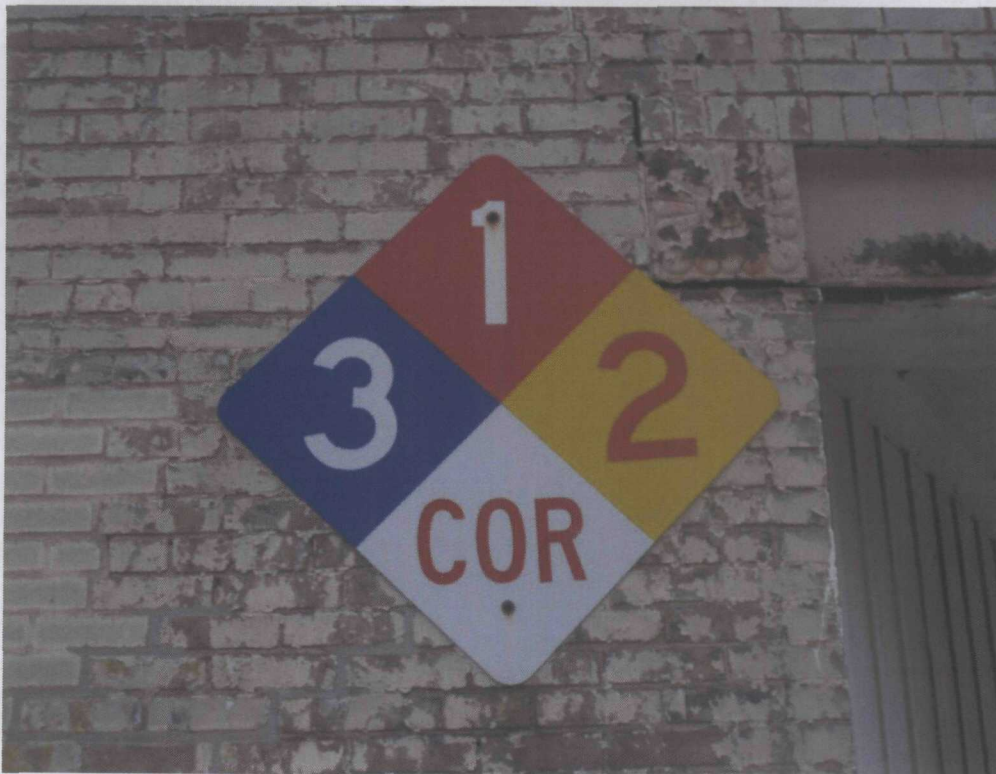
**Date:** March 17, 2010  
**Time:** 9:33 a.m.  
**Direction:** N  
**Photo by:** Charlie King  
**Exposure #:** 004  
**Comments:** The hazardous materials warning placard on the south side of the building.

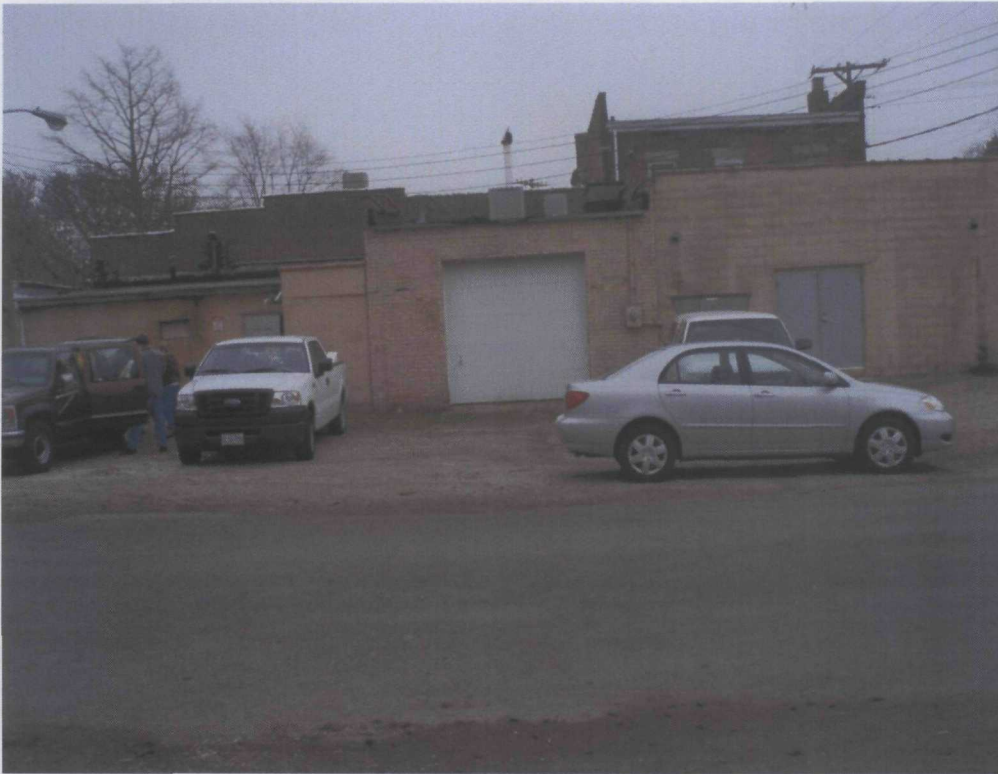
**Date:** March 17, 2010  
**Time:** 9:35 a.m.  
**Direction:** E  
**Photo by:** Charlie King  
**Exposure #:** 005  
**Comments:** The back, or west side of the Nutronics building facing N. 9th Street, and several residences.

The Chemical Storage Room is located behind the garage door, and the Plating Room is located behind the double doors to the south of the garage door.

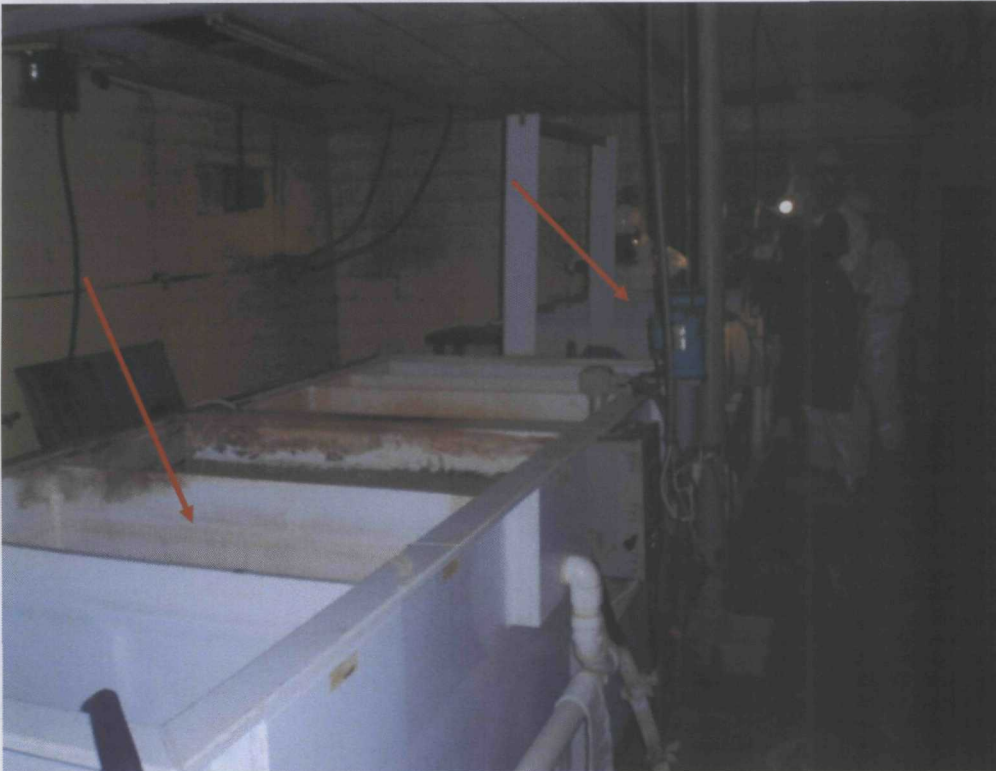
**Date:** March 17, 2010  
**Time:** 10:29 a.m.  
**Direction:** SW  
**Photo by:** Charlie King  
**Exposure #:** 007  
**Comments:** An overview of the Plating Room, as seen from the east interior door.

Vat # 1 is at the end of the right superimposed red arrow.

Vat # 2 is at the end of the left superimposed red arrow.

Samples X201, X202, X203, X204, X205, X206, X207, X208, & X209 were collected in the Plating Room.

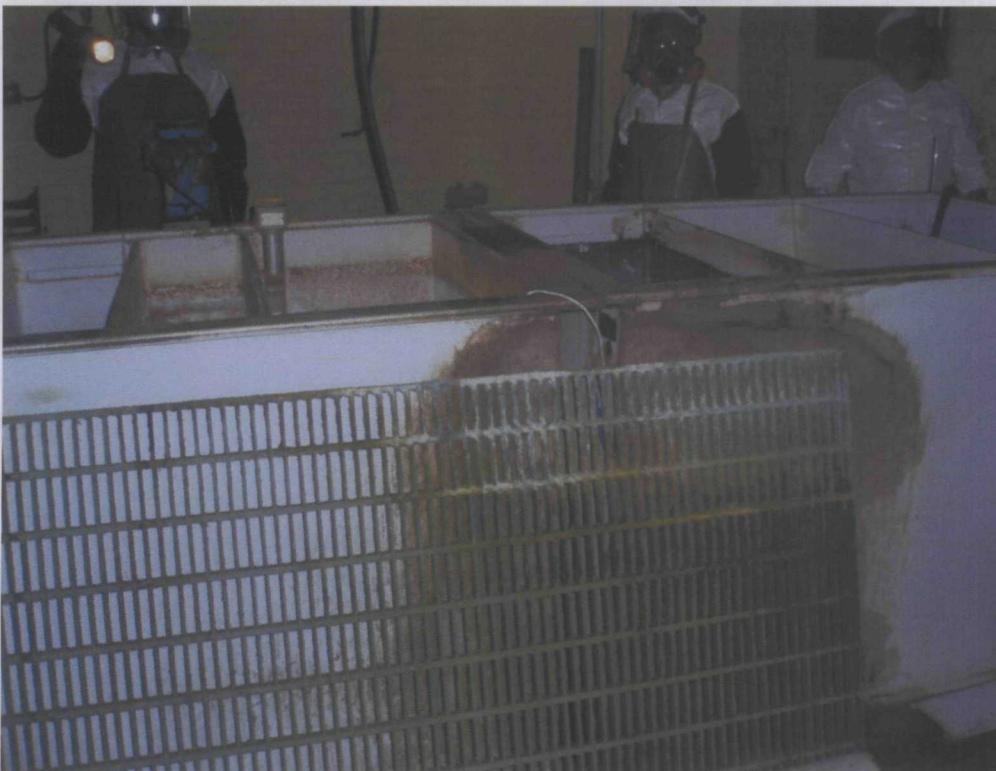
**Date:** March 17, 2010  
**Time:** 11:09 p.m.  
**Direction:** N  
**Photo by:** Charlie King  
**Exposure #:** 010  
**Comments:** Vat # 2 in the Plating Room had six compartments that were either empty or contained various levels of blue/green liquid waste.

After sampling was completed, the green plastic floor grate leaning on the side of the vat was placed over the top of Vat # 2.

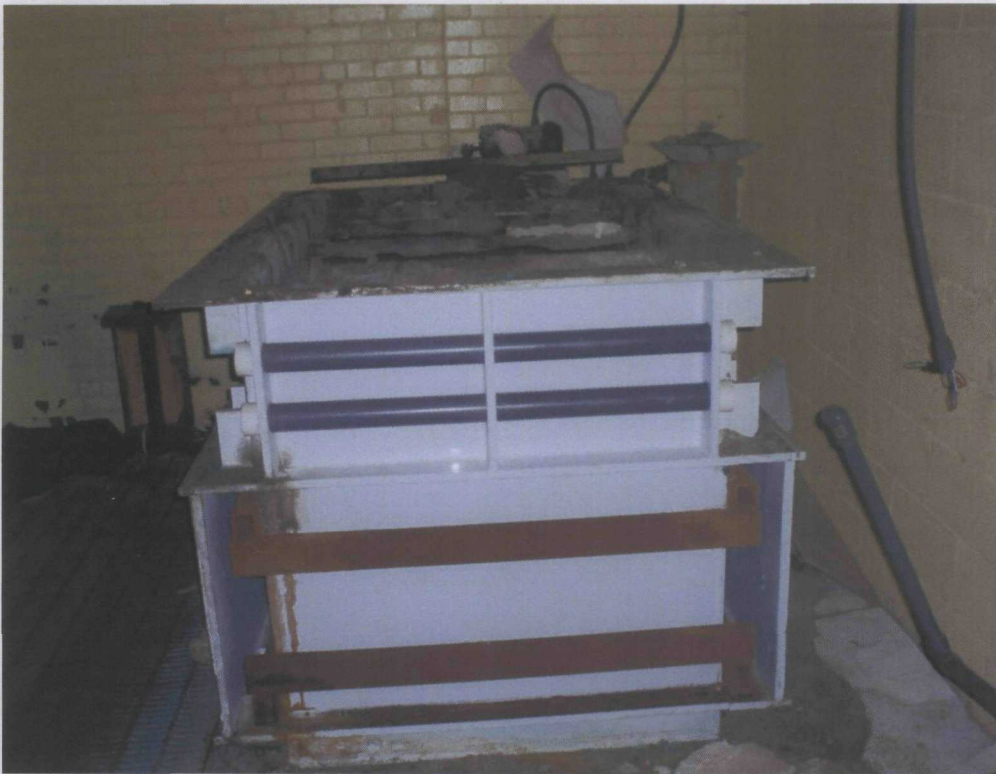
**Date:** March 17, 2010  
**Time:** 11:10 a.m.  
**Direction:** E  
**Photo by:** Charlie King  
**Exposure #:** 011  
**Comments:** Vat # 3 that contained a clear brown liquid waste. Note that some parts of ceiling tiles on top of the vat toward the east wall, and on the floor at the lower right of the photo.

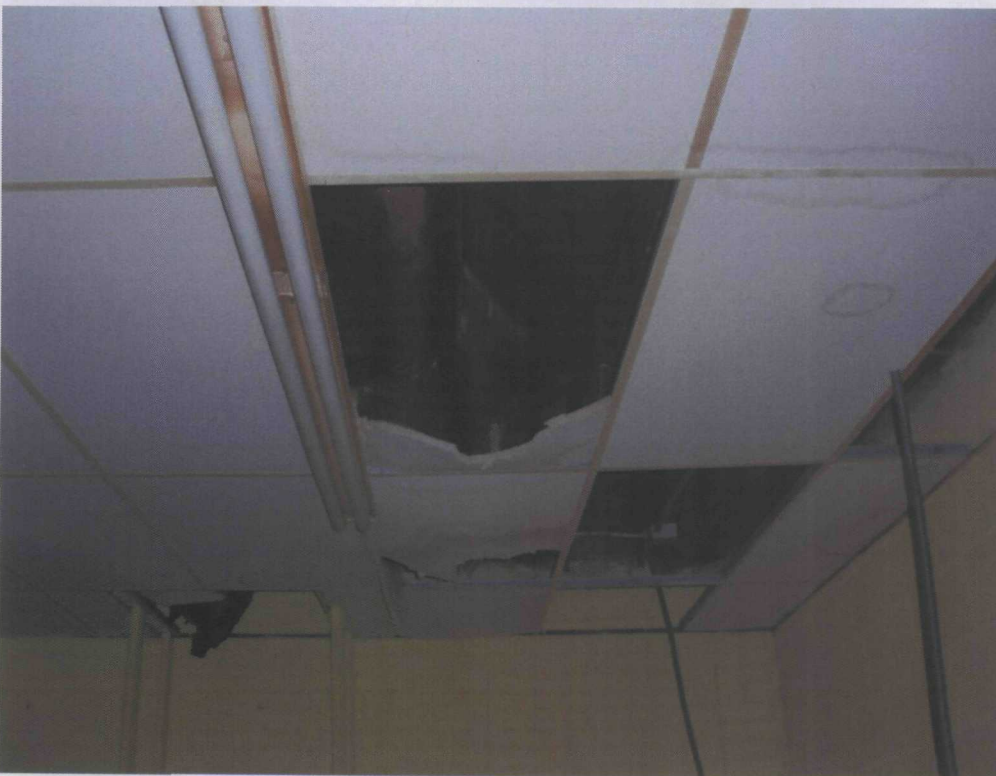
**Date:** March 17, 2010  
**Time:** 11:10 a.m.  
**Direction:** E  
**Photo by:** Charlie King  
**Exposure #:** 012  
**Comments:** The ceiling above Vat # 3. Some of the ceiling tiles had fallen onto the floor and into Vat # 3.

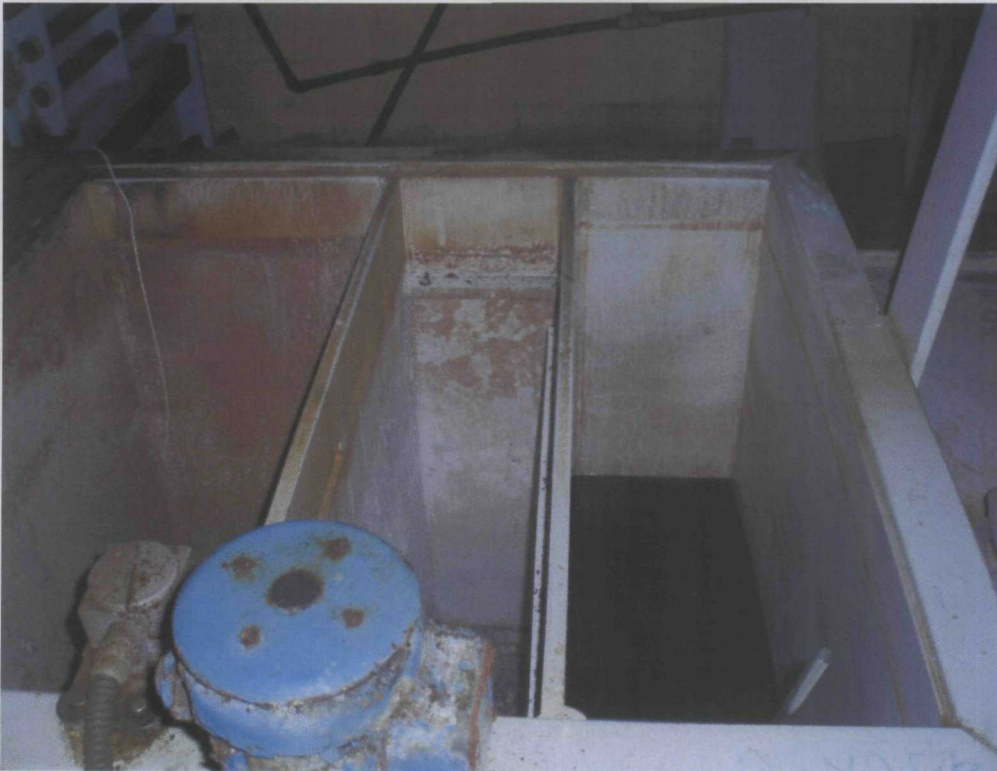
**Date:** March 17, 2010  
**Time:** 12:29 p.m.  
**Direction:** SE  
**Photo by:** Charlie King  
**Exposure #:** 024  
**Comments:** An overview of the first three compartments (1-3), west to east, or right to left, in Vat # 2.

The second and third compartments were empty.

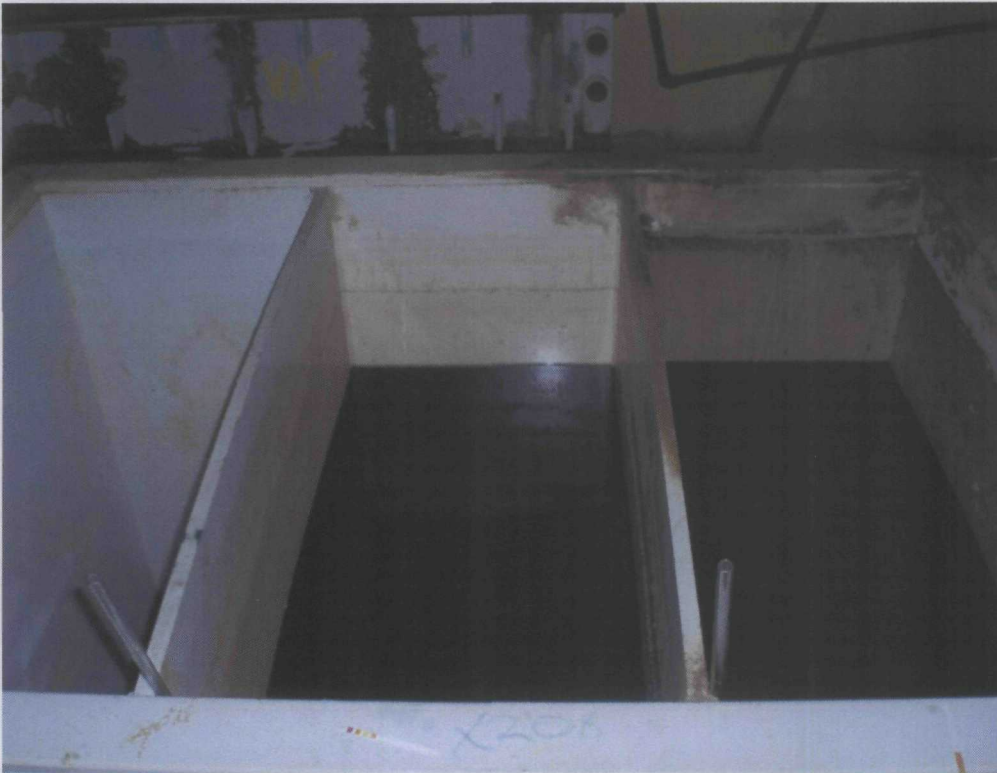
Date: March 17, 2010  
Time: 12:31 p.m.  
Direction: S  
Photo by: Charlie King  
Exposure #: 025  
Comments: An overview of the last three compartments (4, 5 and 6) of Vat # 2. The sixth compartment had only about an inch of liquid waste and was not sampled.

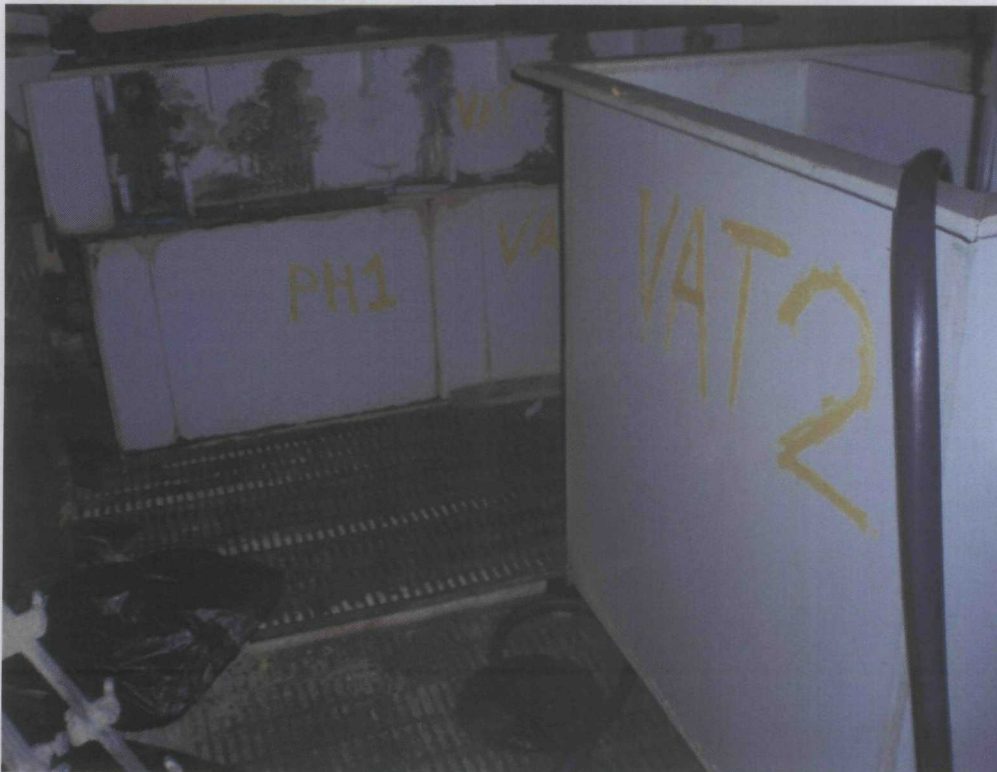
Date: March 17, 2010  
Time: 12:31 p.m.  
Direction: SW  
Photo by: Charlie King  
Exposure #: 026  
Comments: The east end of Vat # 2 and the north side of Vat # 3.

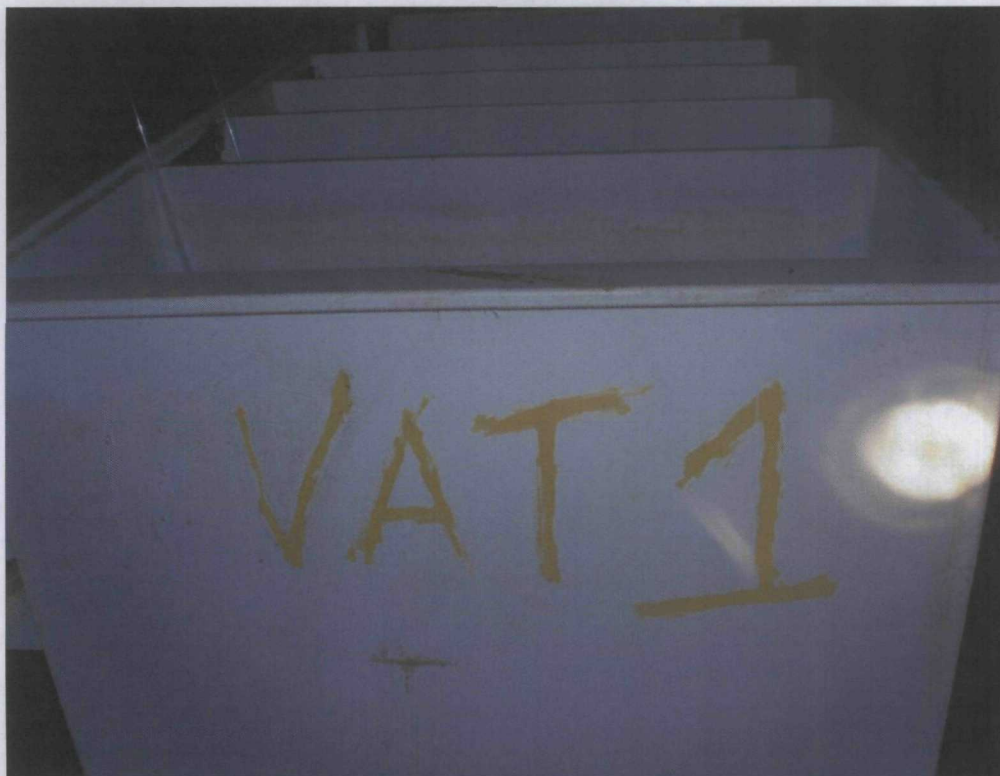
Date: March 17, 2010  
Time: 12:34 p.m.  
Direction: E  
Photo by: Charlie King  
Exposure #: 027  
Comments: The west edge of Vat # 1.

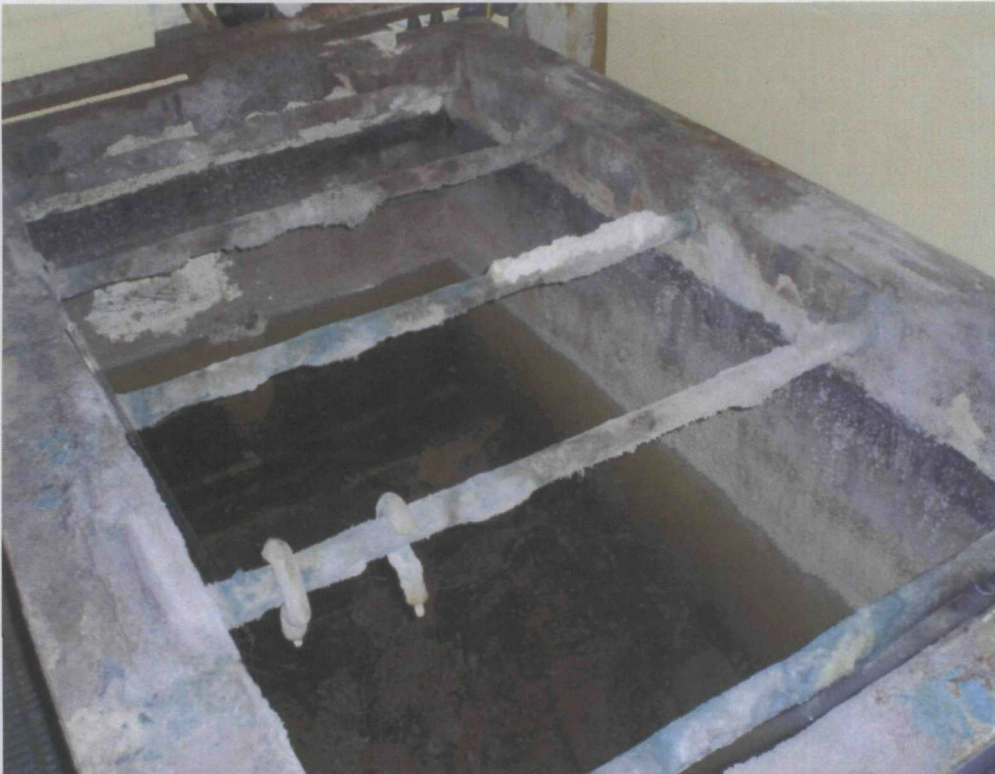
**Comments:** Vat # 3 had only one compartment with a clear brown liquid. It had blue/green and white to brown crusty residue on the internal sidewalls and on the four bars crossing the top.

Some of the fluid in the vat became turbid after sampling. It also had some parts of ceiling tiles in it.

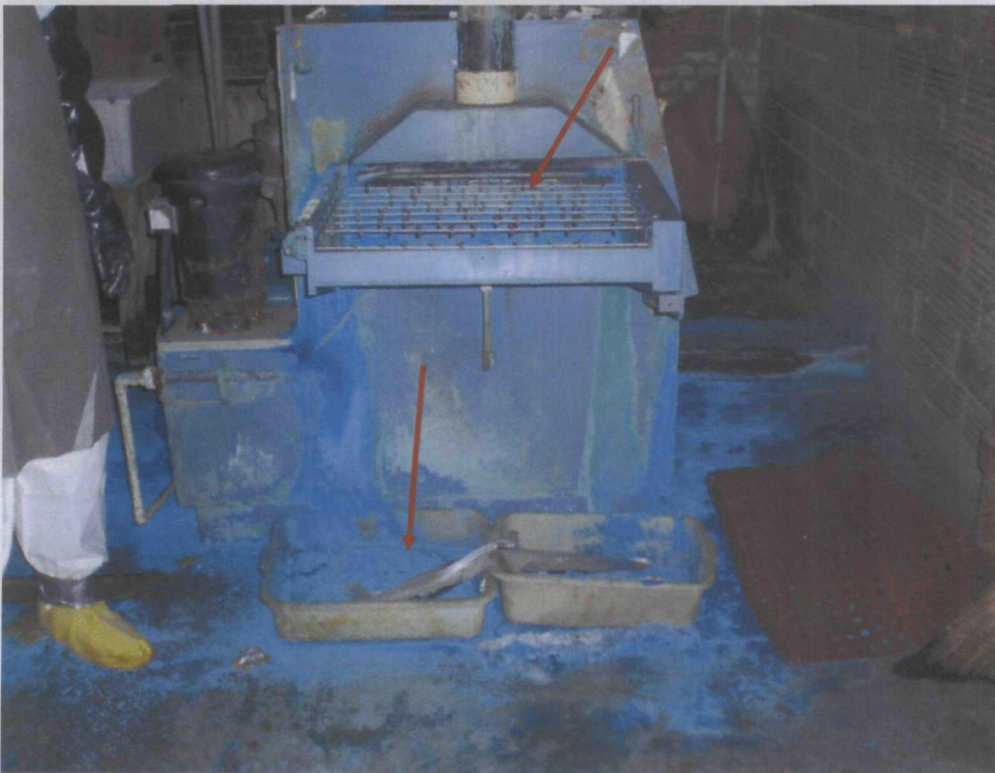
**Comments:** The copper etching machine, and parts of the floor, covered in blue/green crusty residue.

Sample X210 was taken from the plastic box at the end of the bottom red arrow.

Top red arrow points to a wire shelf that the plastic box was placed on to get it into a better position to sample.

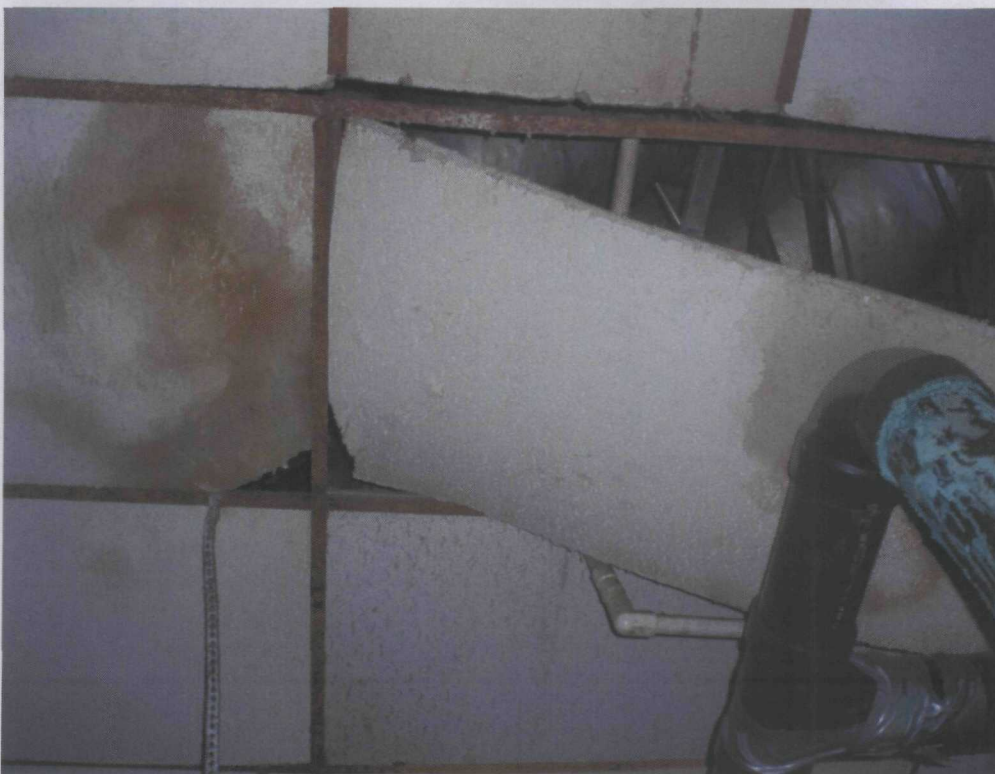
Date: March 17, 2010  
Time: 1:17 p.m.  
Direction: SW  
Photo by: Charlie King  
Exposure #: 032  
Comments: Water damaged ceiling tiles above a pipe with a blue/green crusty residue, located near the copper etching machine shown in Photo # 030.

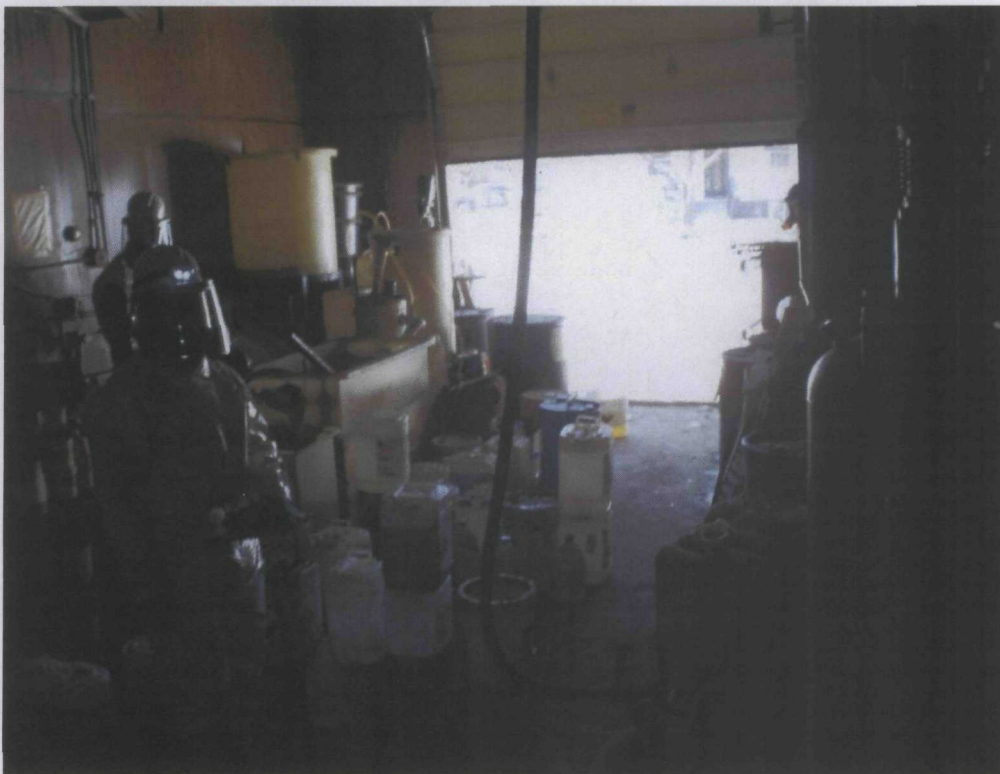
**Date:** March 17, 2010  
**Time:** 1:19 P.M.  
**Direction:** SW  
**Photo by:** Charlie King  
**Exposure #:** 033  
**Comments:** An overview of the Chemical Storage Room, separated from the Plating Room by the south wall at left. The photo was taken from the east interior doorway to this room.

Samples X211, X212, X213, X214, and X215 were collected in the Chemical Storage Room.

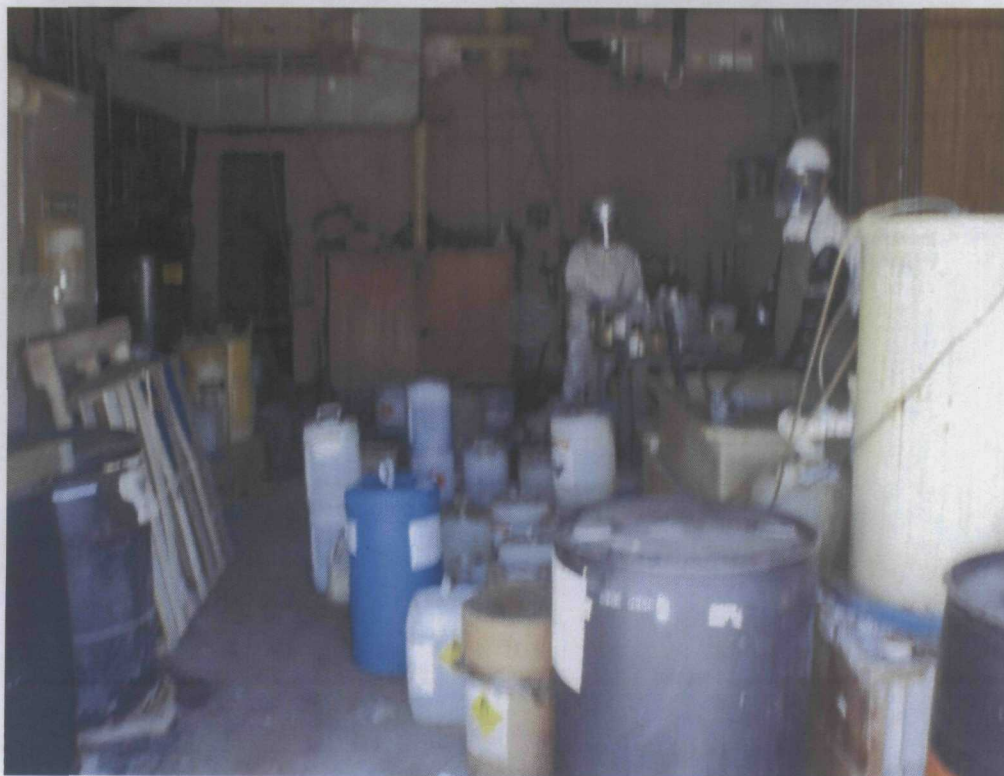
**Date:** March 17, 2010  
**Time:** 1:20 p.m.  
**Direction:** E  
**Photo by:** Charlie King  
**Exposure #:** 034  
**Comments:** An overview of the Chemical Storage Room, as shown from near the garage door.

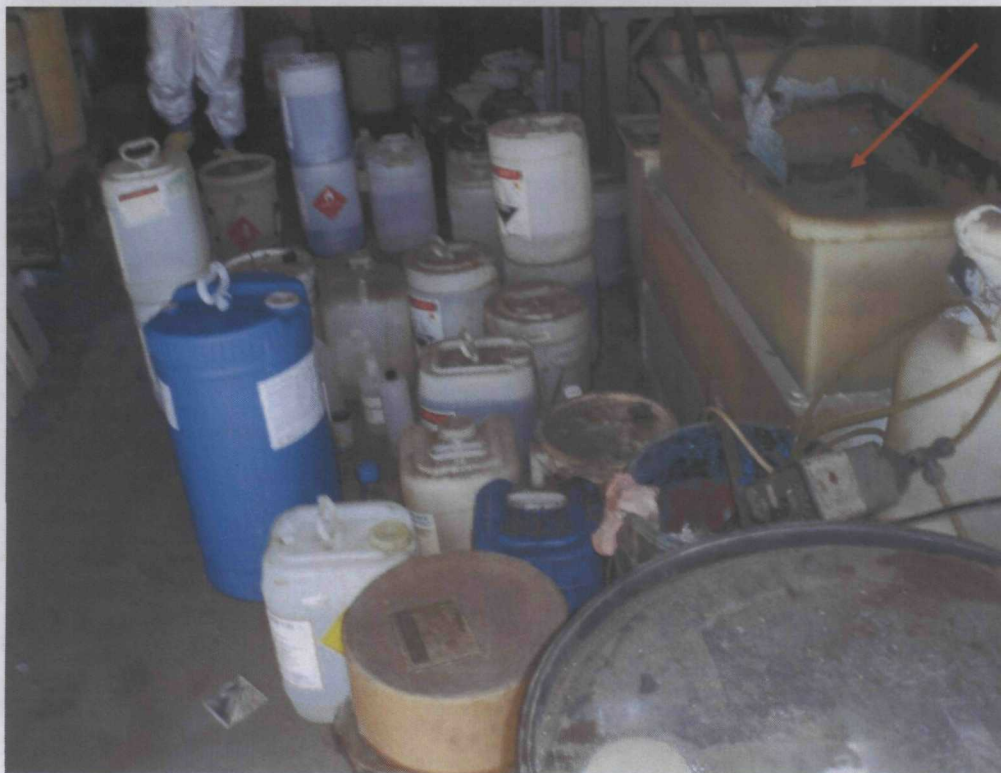
**Date:** March 17, 2010  
**Time:** 1:20 p.m.  
**Direction:** E  
**Photo by:** Charlie King  
**Exposure #:** 036  
**Comments:** Numerous five-gallon and larger containers of wastes in the Chemical Storage Room.

At the end of the red arrow is Vat # 4, which contains blue/green, white, and brown crusty residues that were sampled (X211).

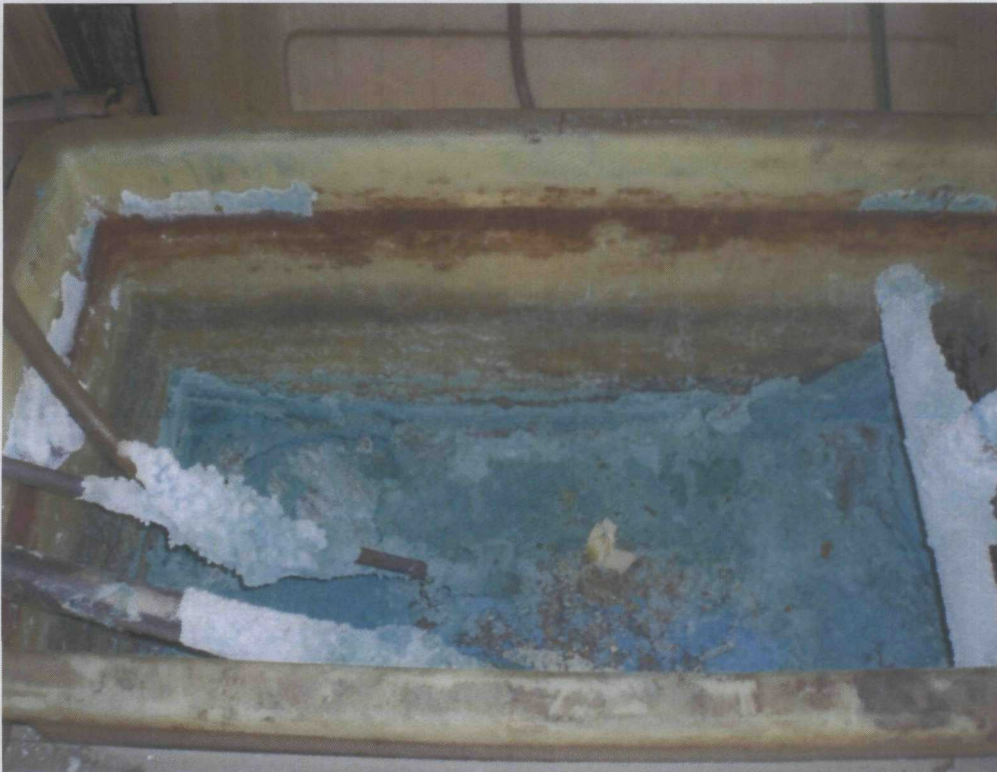
Date: March 17, 2010  
Time: 1:26 p.m.  
Direction: S  
Photo by: Charlie King  
Exposure #: 037  
Comments: The blue/green, and white crusty residue inside Vat # 4 shown in Photo # 036. A brown crusty residue was underneath the blue/ green residue at the bottom of the vat.

Sample X211 was taken of these residues.

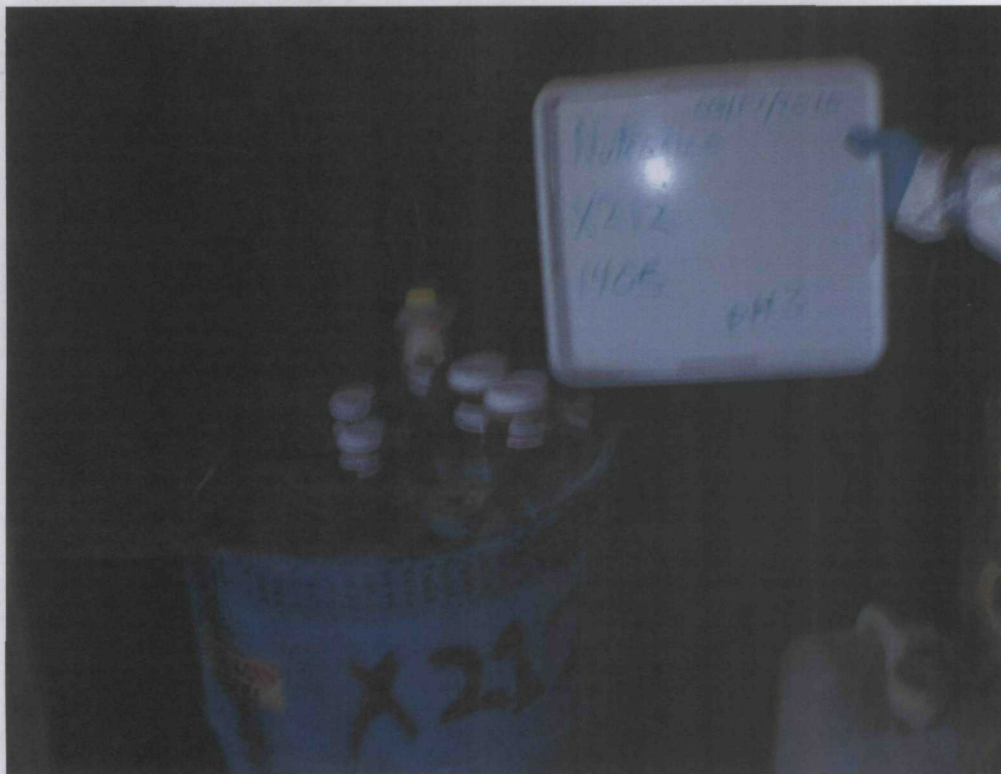
Date: March 17, 2010  
Time: 2:07 p.m.  
Direction: N  
Photo by: Charlie King  
Exposure #: 039  
Comments: Sample # X212 is on top of the 55-gallon blue plastic drum labeled "Tin-Lead Waste!" This brown liquid sample was taken at 2:05 p.m. and had a field pH of 3.

This photo was blurred, so it was taken again, shown below as photo # 040.

Date: March 17, 2010  
Time: 2:07 p.m.  
Direction: N  
Photo by: Charlie King  
Exposure #: 040  
Comments: Another photo of sample # X212.

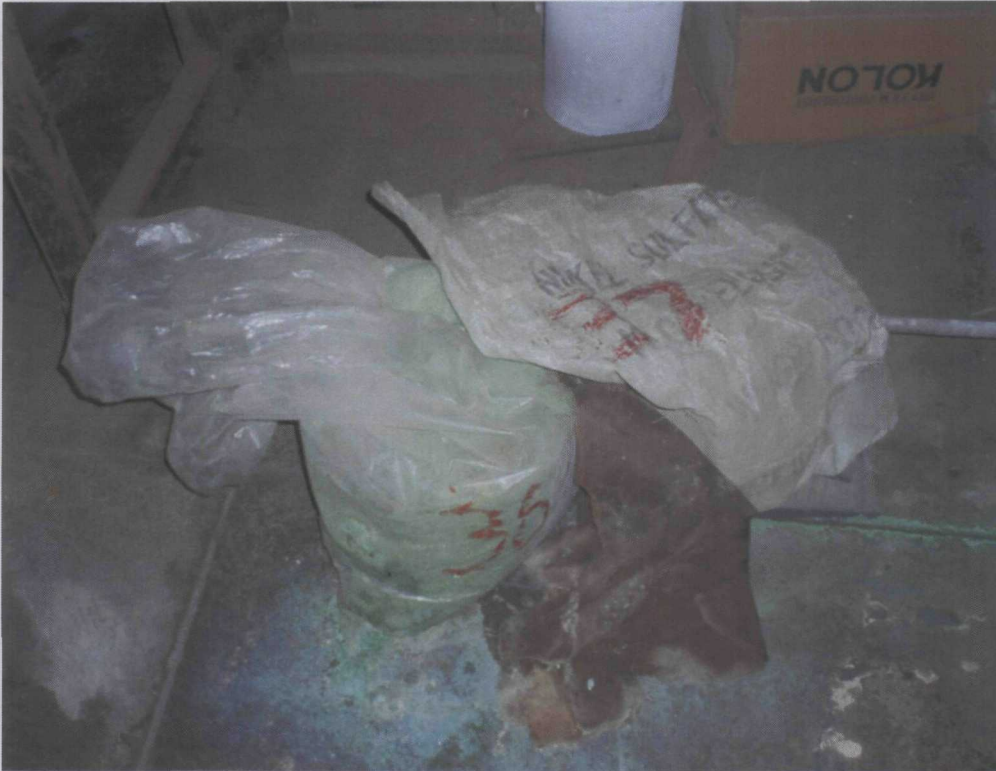
Date: March 17, 2010  
Time: 3:39 p.m.  
Direction: NE  
Photo by: Charlie King  
Exposure #: 045  
Comments: Bags  
marked # 36 and 37 on  
the floor east of the  
copper etching machine.

Clear bag # 36 contained  
a green salt, and bag #  
37 was labeled "NICKEL  
SULFATE".

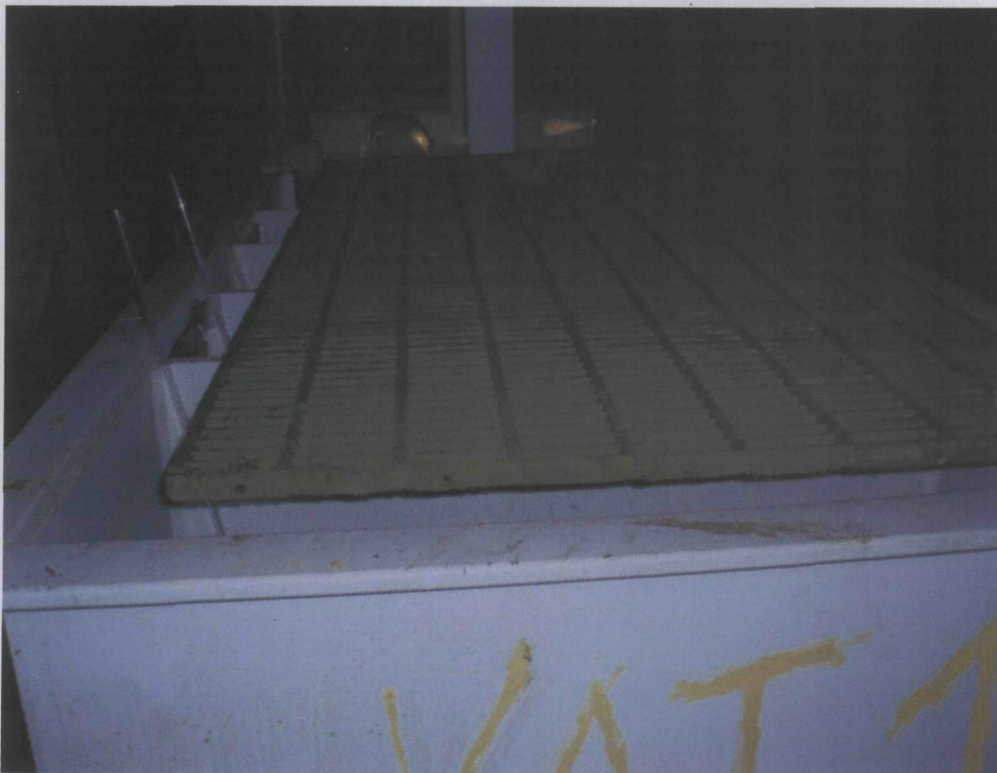
Date: March 17, 2010  
Time: 3:41 p.m.  
Direction: E  
Photo by: Charlie King  
Exposure #: 046  
Comments: This plastic  
floor grate was placed on  
top of Vat # 1 before  
leaving the building. A  
similar floor grate was  
also placed on top of Vat  
# 2.

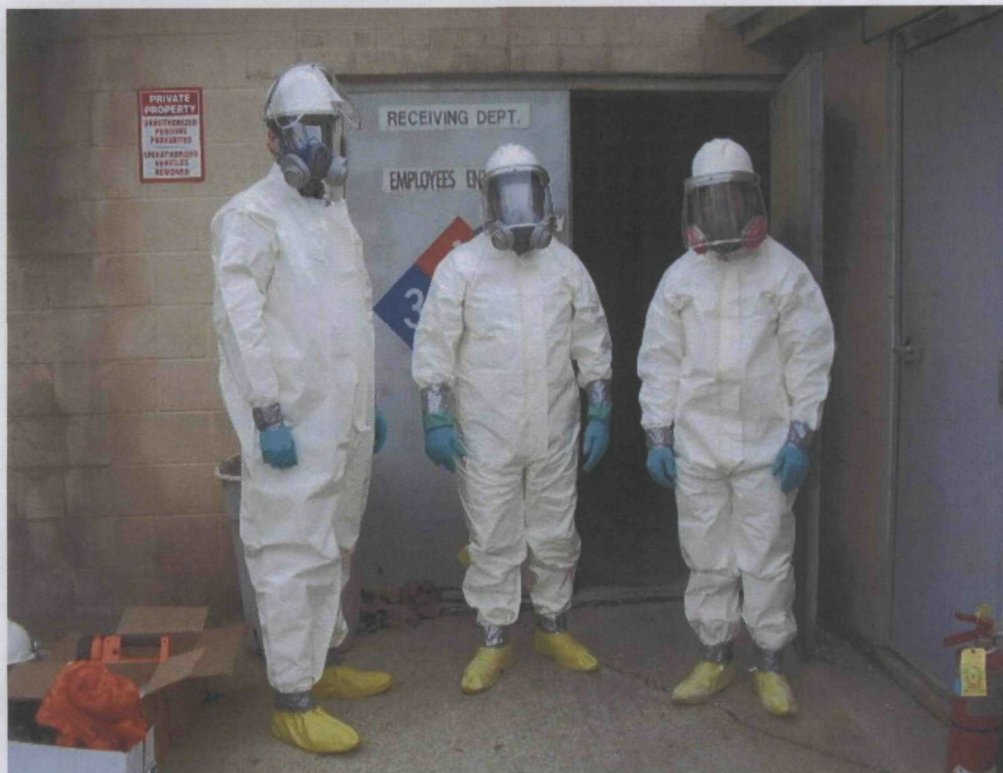
Date: March 17, 2010  
Time: 10:13 a.m.  
Direction: E  
Photo by: Paul Eisenbrandt  
Exposure #: 047  
Comments: Sampling team members, left to right, David Jansen, Mark Weber, and Blaine Kinsley, in Level C protection.

This open door was unlocked by the owner, Bud Darran, to allow entry into the building.

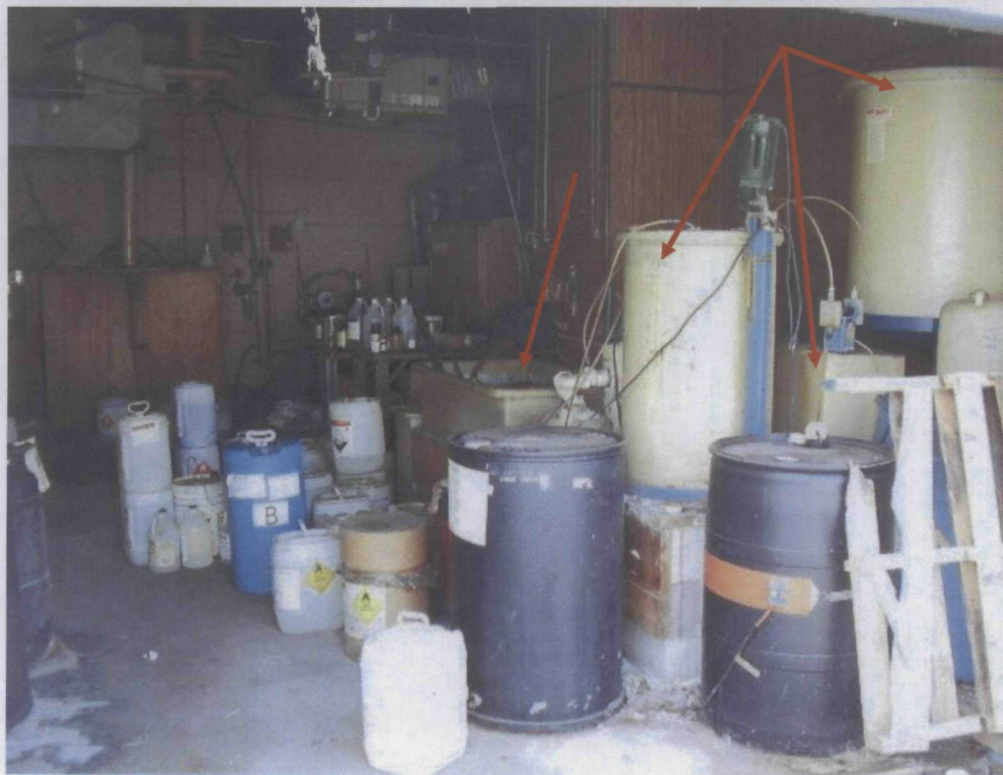
Date: March 17, 2010  
Time: 10:46 a.m.  
Direction: SE  
Photo by: Paul Eisenbrandt  
Exposure #: 048  
Comments: Interior of Chemical Storage Room as seen from outside the garage door.

Sample X211 was collected from Vat # 4 at the end of the left red arrow.

The white plastic tanks at the ends of the 3 red arrows were part of Nutronics' wastewater pre-treatment system.

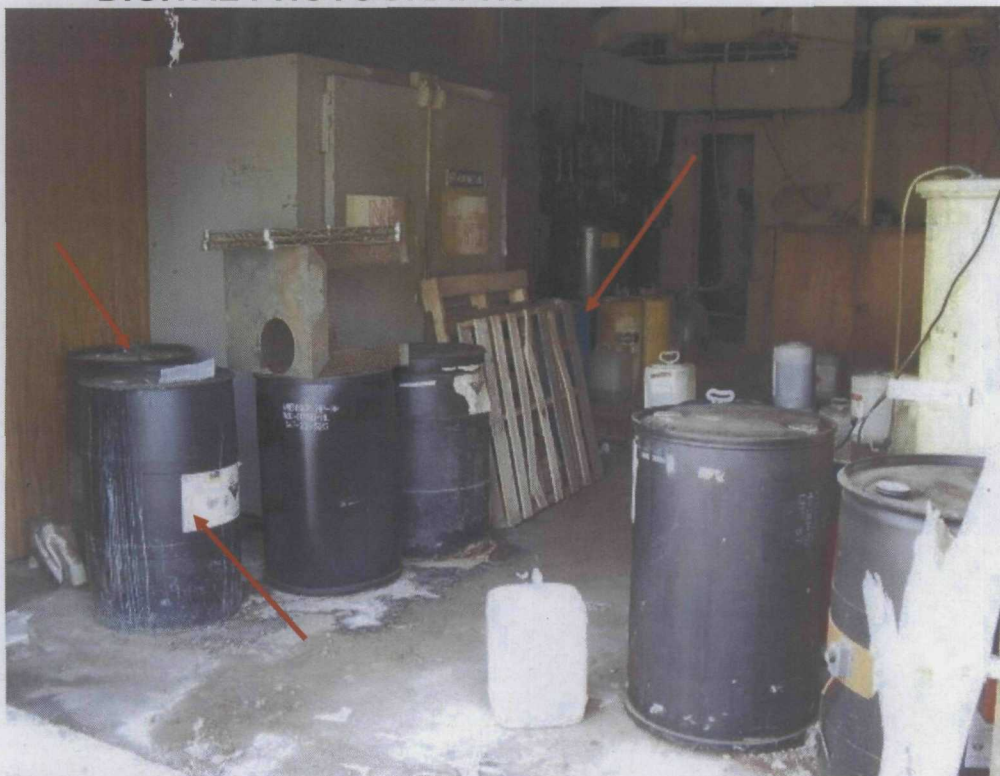
Date: March 17, 2010  
Time: 10:46 a.m.  
Direction: NE  
Photo by: Paul  
Eisenbrandt  
Exposure #: 049  
Comments: Interior of  
Chemical Storage Room  
as seen from outside the  
garage door.

Red arrows point to  
plastic 55 gallon drums  
that were sampled.  
From right to left,  
samples X212, X213,  
and X214 were collected  
from these drums.

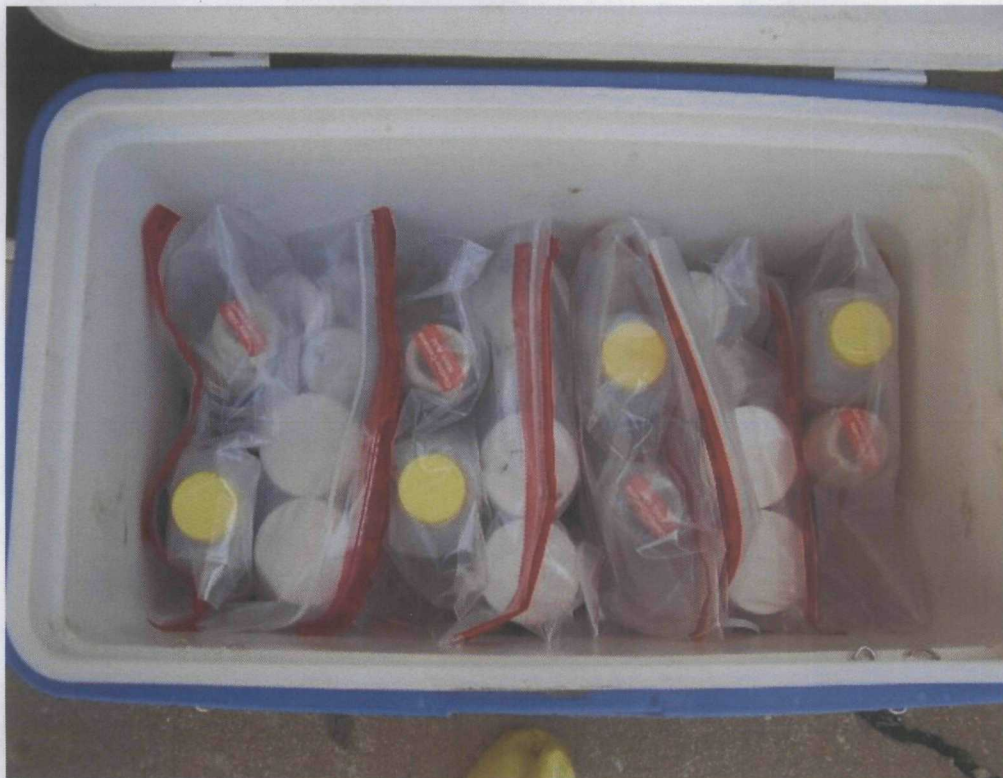
Date: March 17, 2010  
Time: 3:26 p.m.  
Direction: S  
Photo by: Paul  
Eisenbrandt  
Exposure #: 051  
Comments: Waste  
samples packed in  
sealed bags inside  
coolers.
